July 2012

# Extant Timbers at Hamble Yacht Services

## Site Visit Report

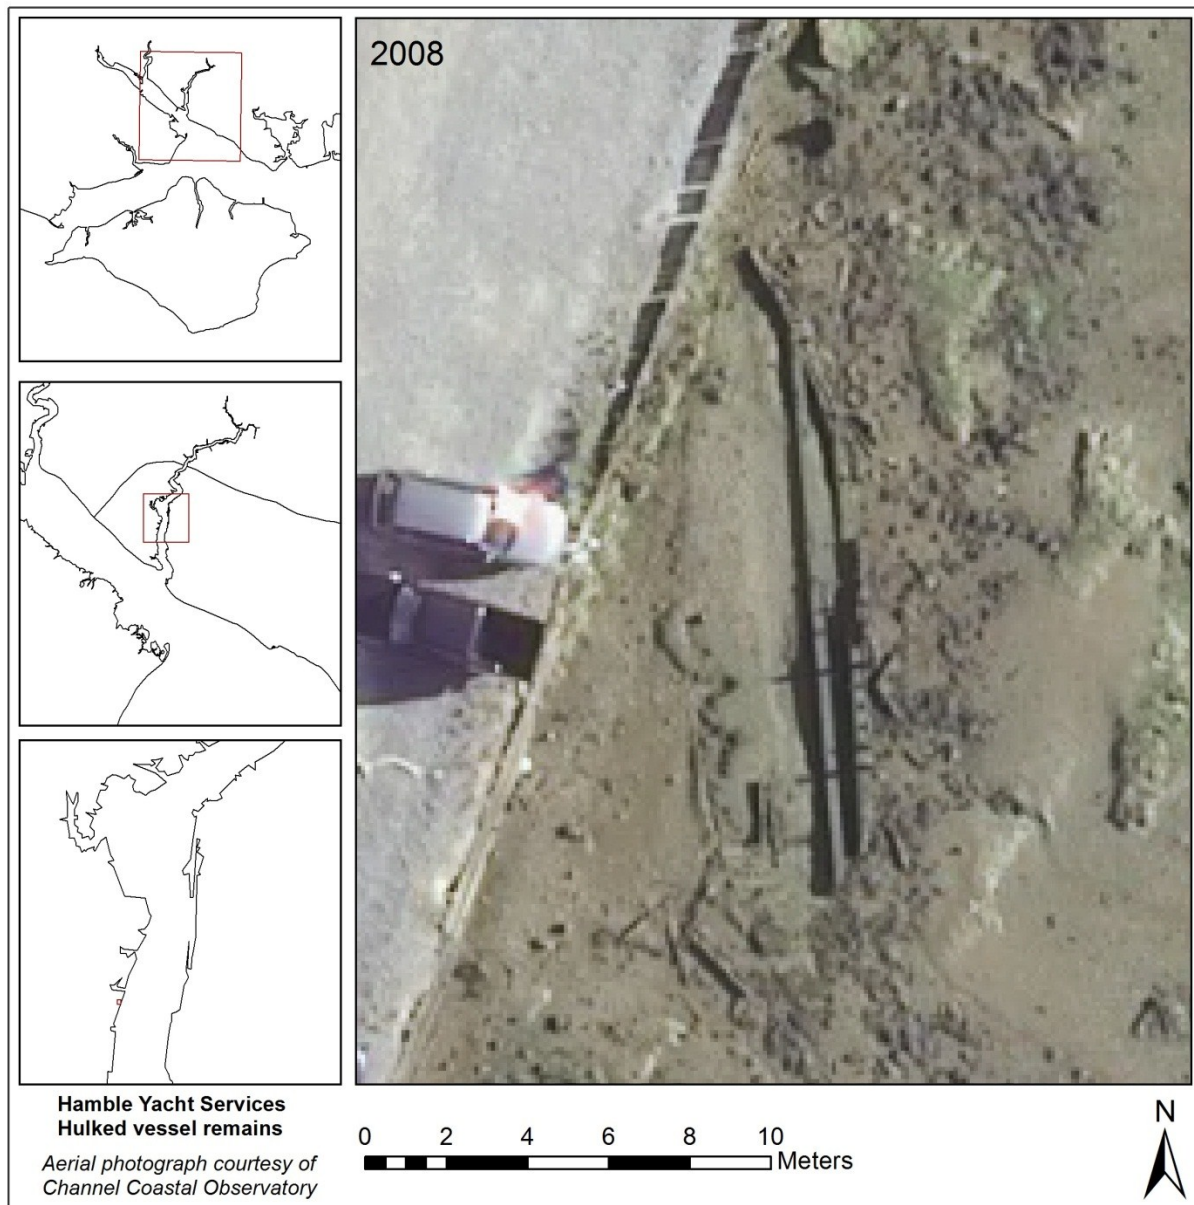
Figure 2. Detailed view of the 2008 aerial photograph in which the coherent remains are visible.

Despite this, it was clear from talking to members of HYS staff that the timbers have been known about for at least 30 years. During this time they appear to have been degrading at a steady rate, while becoming increasingly exposed as foreshore mud levels drop in this area of the River. Available aerial photos of the site, taken in 2008, clearly show the remains of a hulked vessel of some sort (Figure 2), measuring c.17.5m in length and c.4.3m in width. Two substantial longitudinal timbers are visible on the eastern side of these remains.

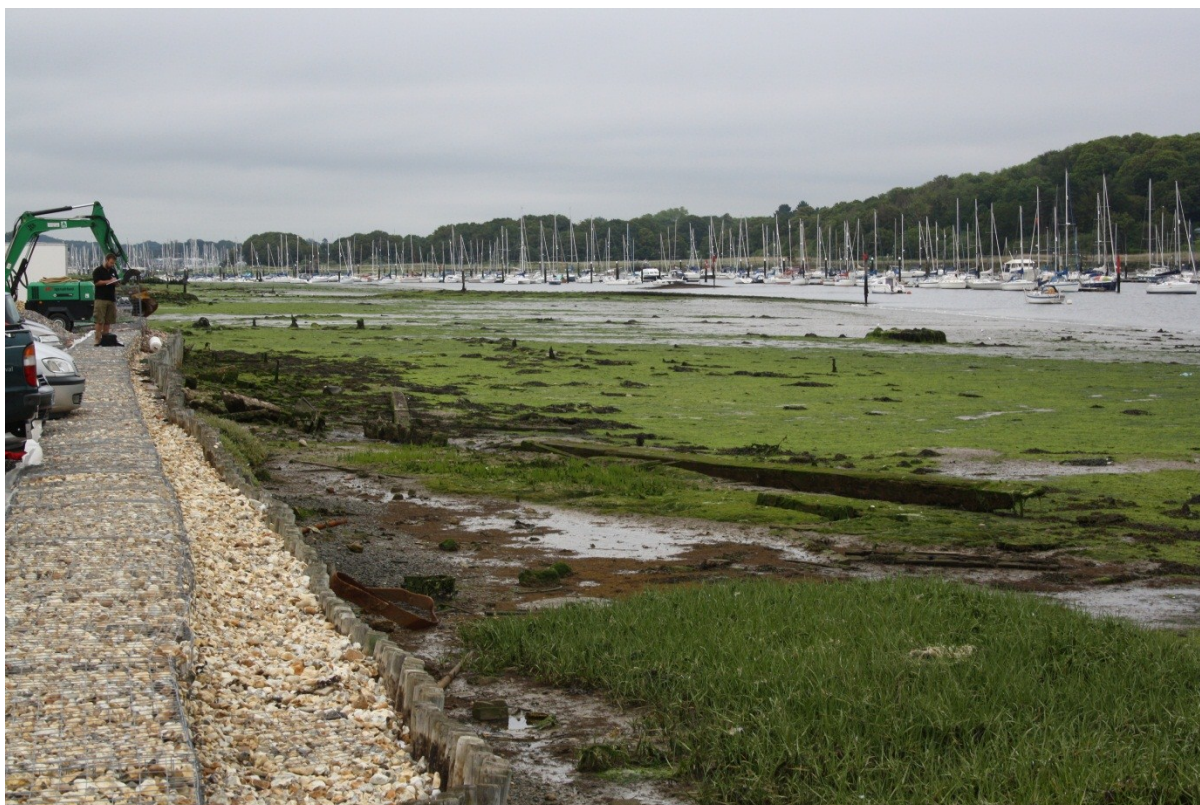
*Figure 3. General view of the site and extant timbers, looking north-east.*

The exposed timbers are located at 50° 51.806'N 001°18.741'W (Datum WGS84), immediately adjacent to the present waterfront that forms the eastern edge of the main car park at HYS (Figure 1 and 3). The exposed timbers cover an area c. 25m in length by 7.5m. Access to the site is easily gained from the present waterfront and the mud in across the site is suitable for walking on, with suitable footwear. The time allowed for the site visit did not permit a full survey of the site to be conducted, however a sketch plan was taken, along with key measurements allowing the sketch to be scaled to represent the disposition of material at the site (Figure 4).

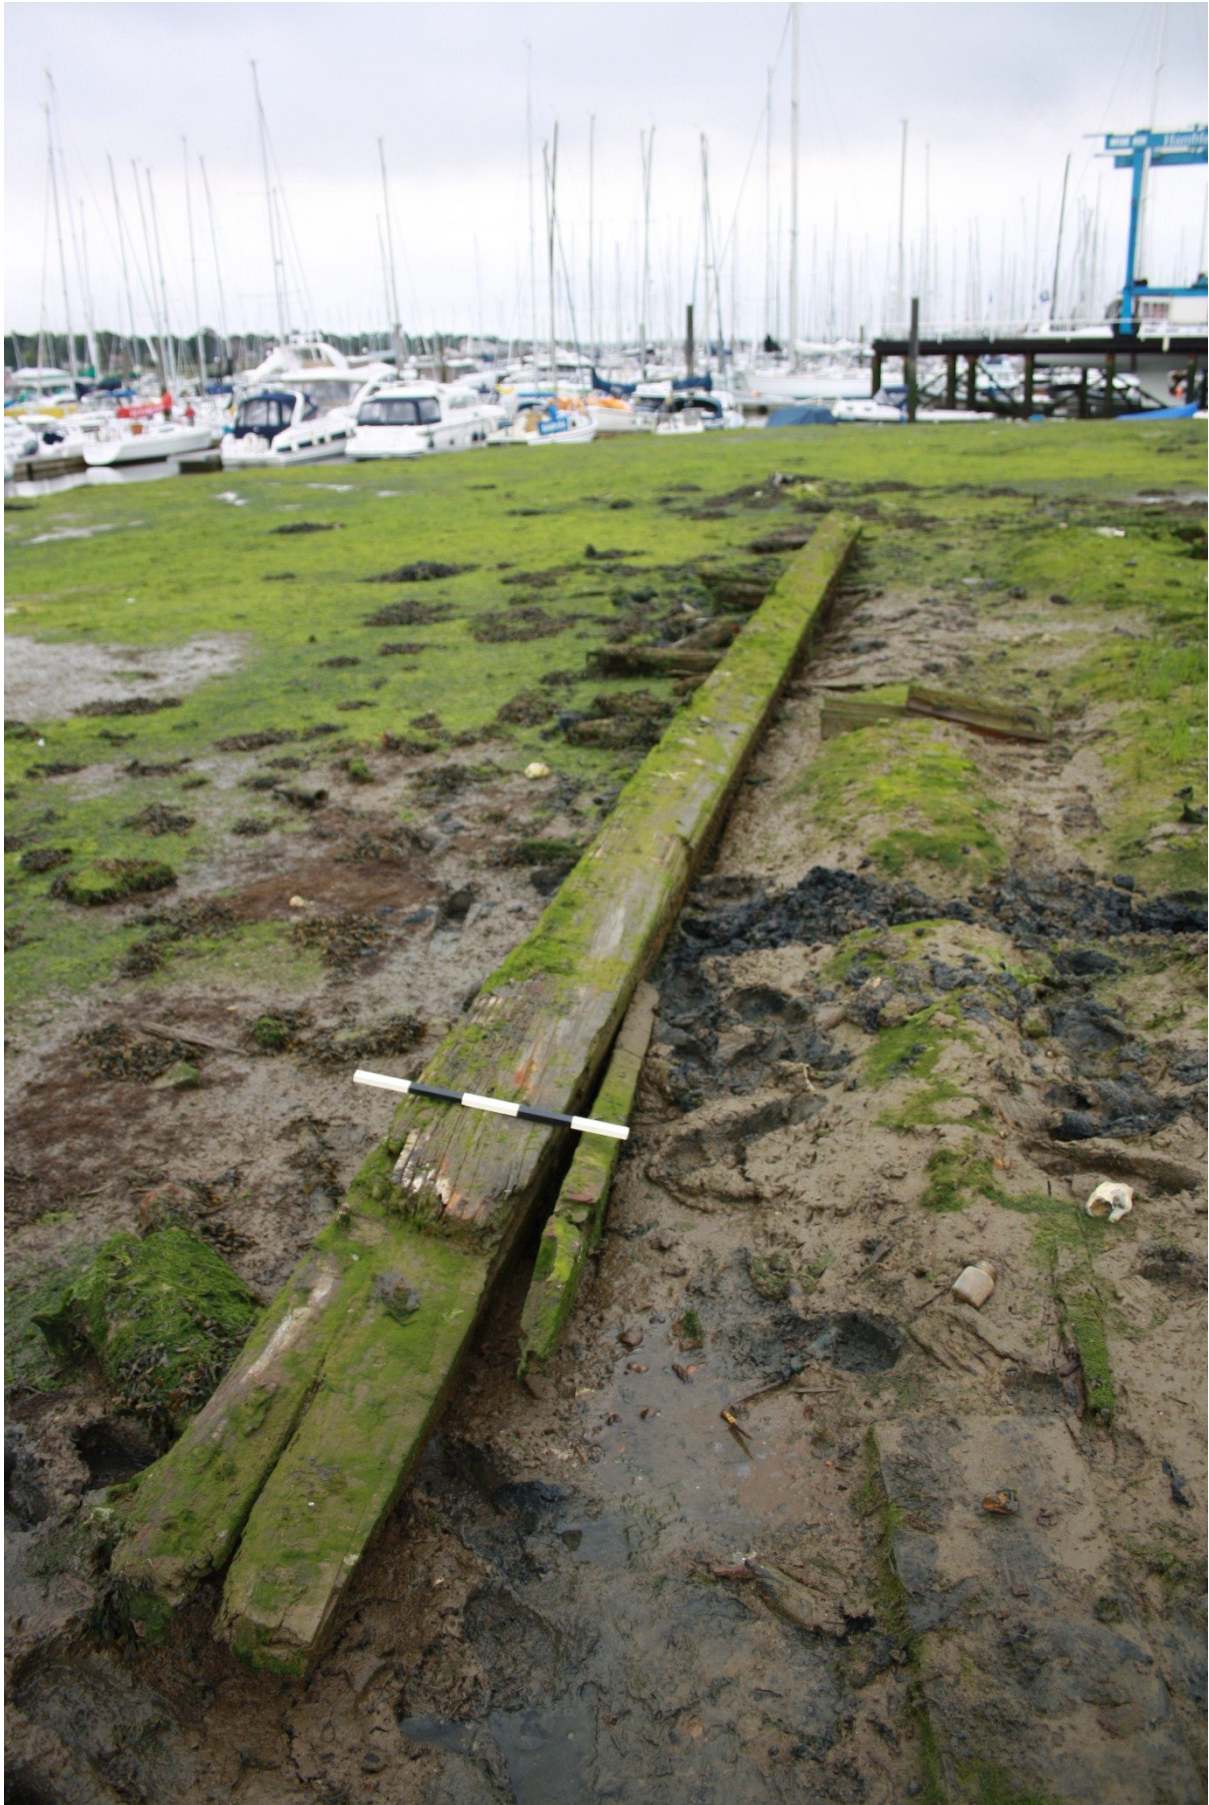
Timber 1 (Figure 5) lies at the southern end of the site and measures 11.06m in length. In its current disposition it has a breadth of 290mm and a depth of 250mm. However, the growth of weed and other marine organisms suggests that the timber has rolled over by c. 90° in the direction of the river. A diagonal face at one end of the timber, suggestive of a scarf joint, measures 0.75m in length. The current underside of the timber is notched to receive a series of much smaller timbers, some of which are still preserved in-situ. The visible notches average 140mm in width and are spaced an 550mm centres. The timbers that are placed in these notches, lying perpendicular to timber 1, are quite poorly preserved, but appear to measure c. 110mm sided by 100mm moulded. These timbers protrude for a maximum of one metre. In one area, planking is secured to the exterior of these timbers, running in line with Timber 1, this has a thickness of 30mm and a width of 170mm. An iron knee is also preserved (Figure 6), lying amongst the perpendicular timbers. It comprises a straight right-angled knee with arms 580mm and 850mm in length, 70mm moulded at their junction and tapering to 20mm moulded at their tip. The angle between the arms is c.100°.

*Figure 5. View of Timber 1, looking south, scale =50cm.*

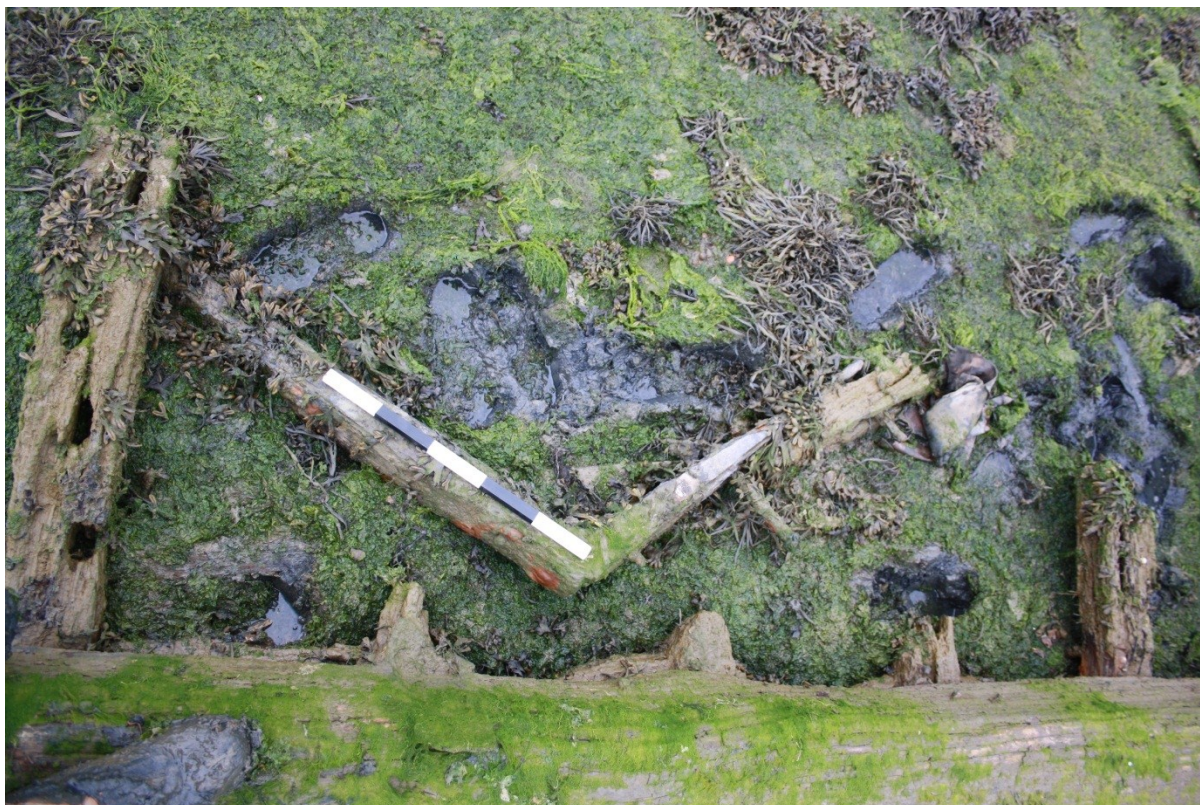
Figure 6. Iron frame located adjacent to Timber 1, scale =50cm.

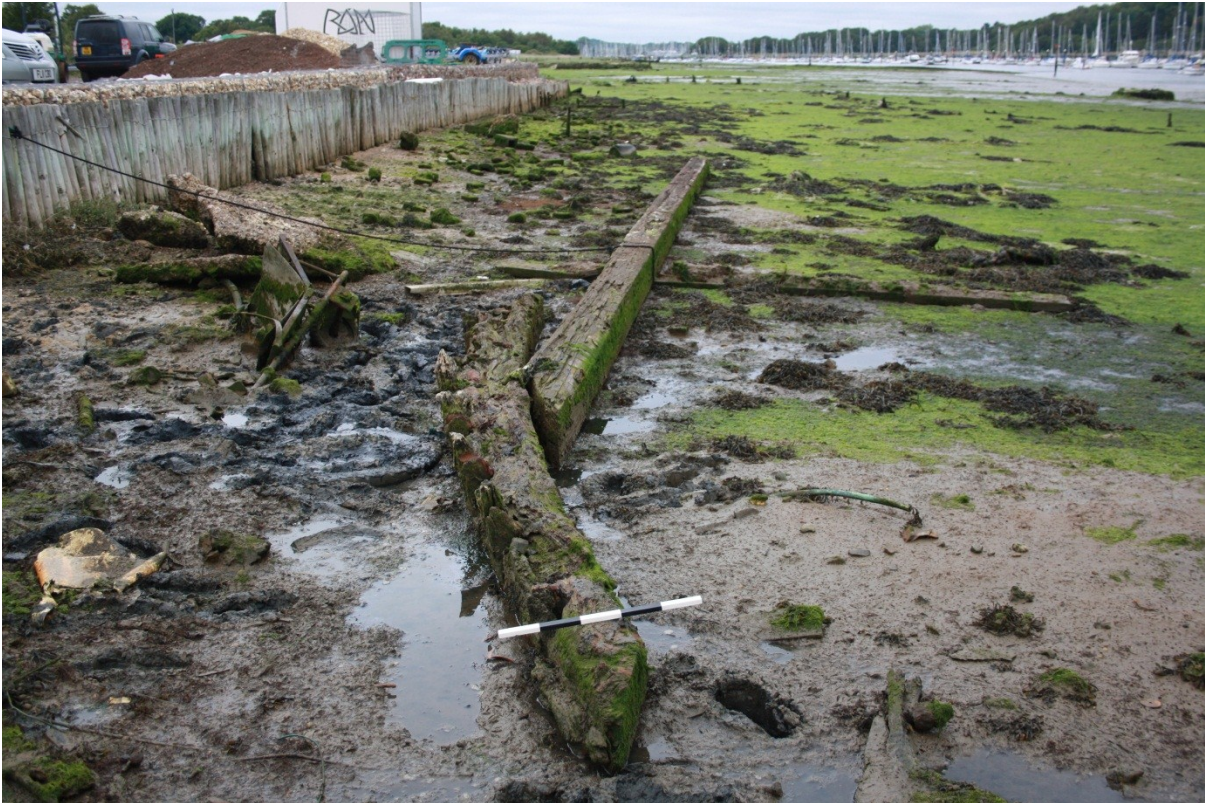
Timber 2 (Figure 7) lies approximately four metres to the north of timber 1 and measures 13.91m in length. In its current disposition it has a breadth of 240mm and a depth of 280mm. However, the growth of weed and other marine organisms suggests that the timber has rolled over by c. 90° in the direction of the river. A diagonal face at one end of the timber, suggestive of a scarf joint, measures 0.47m in length. Staff at HYS report that timber 2 has dried out enough to regain some buoyancy and often shifts position, within the site, at high-water. To prevent it from drifting away, it has been tied to the riverbank. It is clear from discussion with HYS staff and from impressions left in the mud, that timber 2 was formerly located parallel to timber 1, towards the riverbank.

Timber 3 (Figure 7 and 8) is the smallest of the three main timbers and lies between timber 1 and 2, slightly overlapping timber 2. Timber 3 measures 5.18m in length and in its current disposition has a breadth and depth of 290mm. Unlike timbers 1 and 2, there is no indication that timber 3 has rolled over recently, in any direction. A diagonal face at one end of the timber, suggestive of a scarf joint, measures 0.76m in length. Timber 2 has a clear curve along its entire length (Figure 7). The outside of the curve is notched in order to receive a series of smaller timbers, some of which remain in-situ. The visible notches measure 130-140mm in width and are located on 550mm centres. The preserved timbers are 90mm moulded, they are too degraded for a sided dimension to be recorded. These timbers are fastened to timber 2 with a pair of iron bolts that measure 20mm in diameter.

*Figure 7. View of Timber 2 and Timber 3 (foreground) looking north, scale =50cm.*

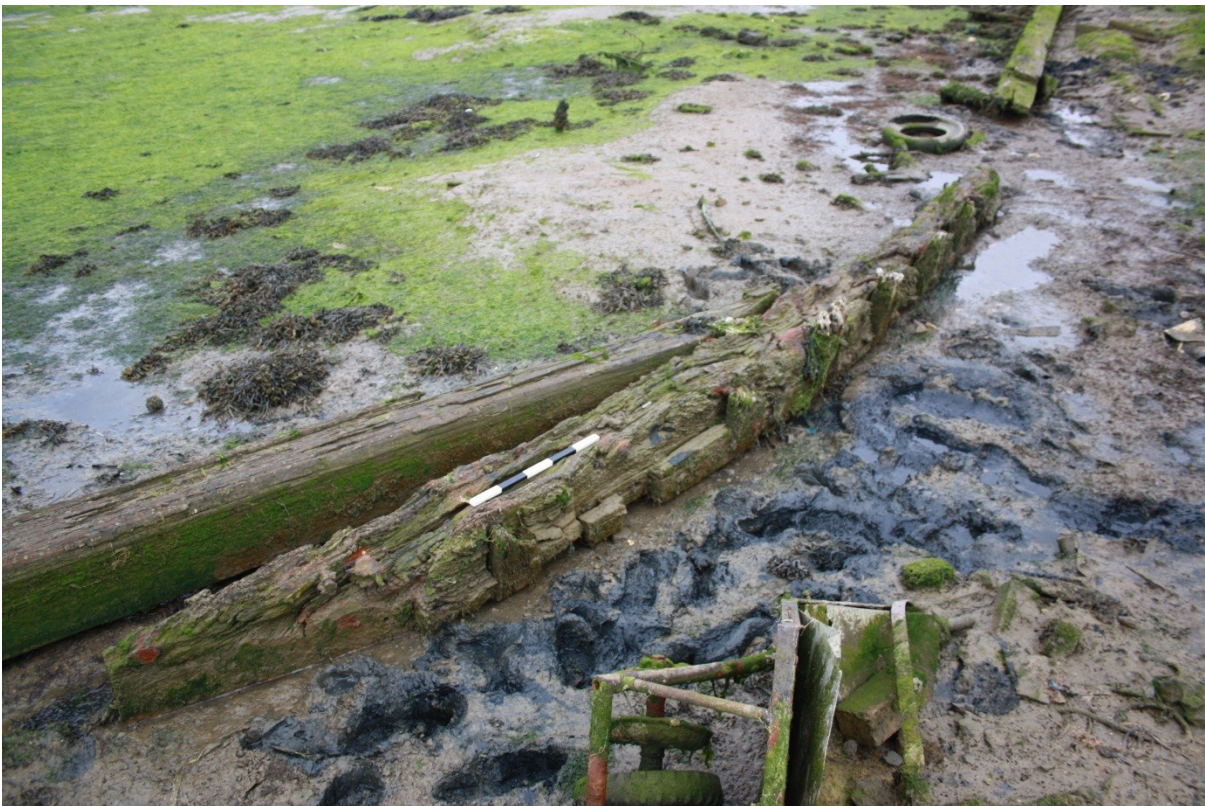
*Figure 8. View of Timber 3, scale =50cm.*

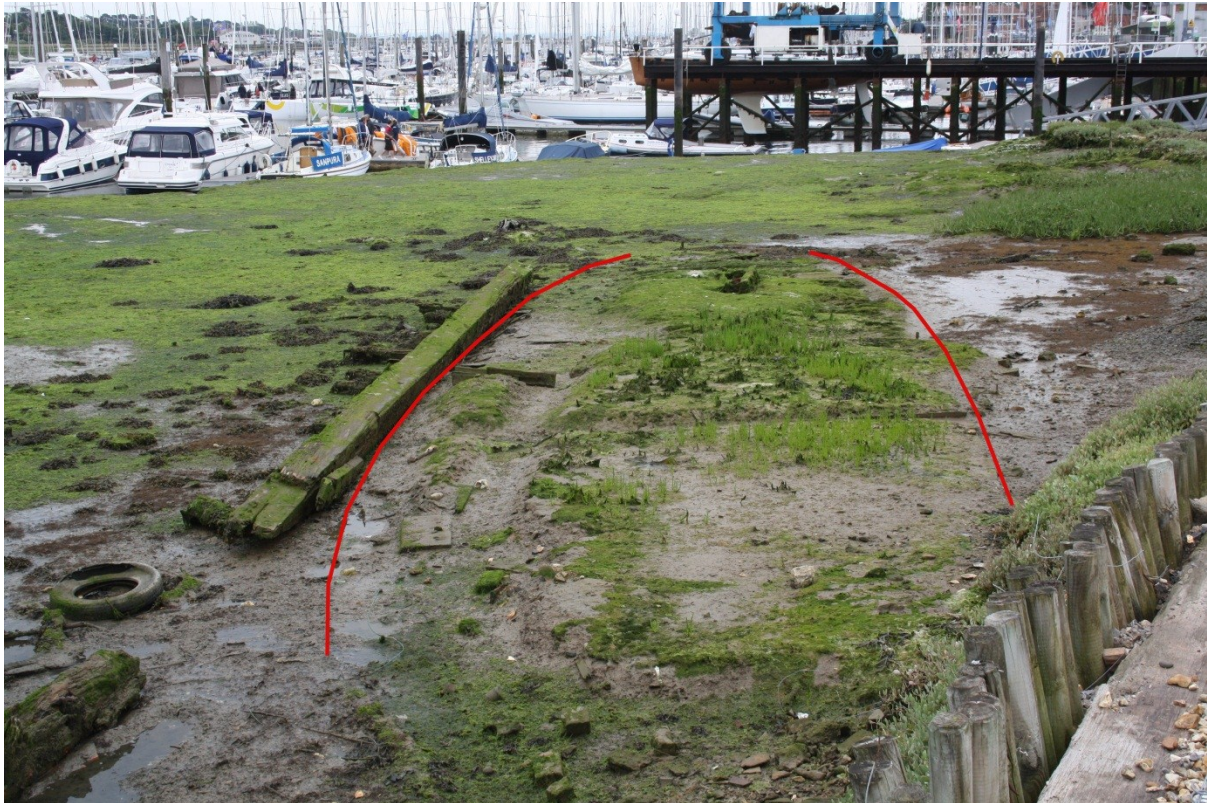
A large area of planking lies between timber 1 and the river bank (Figure 9), extending for at least 13m. At its widest point, a single plank was recorded that measured 4.23m in length with a width of 270mm. This plank was c.50mm and had a diagonal bevel on its outer end, the acute angle of the bevel being uppermost. The area of planking is clearly curved towards along its western and eastern edges, with the points where the two curves meet lying at the northern and southern ends of the site. The planking extends to the very edge of timber 1 and is currently overlain by a layer of sediment c. 5cm thick. All of the planking lies perpendicular to timber 1, no evidence of any edge-to-edge joining was observed.

Figure 9. Area adjacent to Timber 1, containing the remains of the vessel's bottom planking, delineated in red.

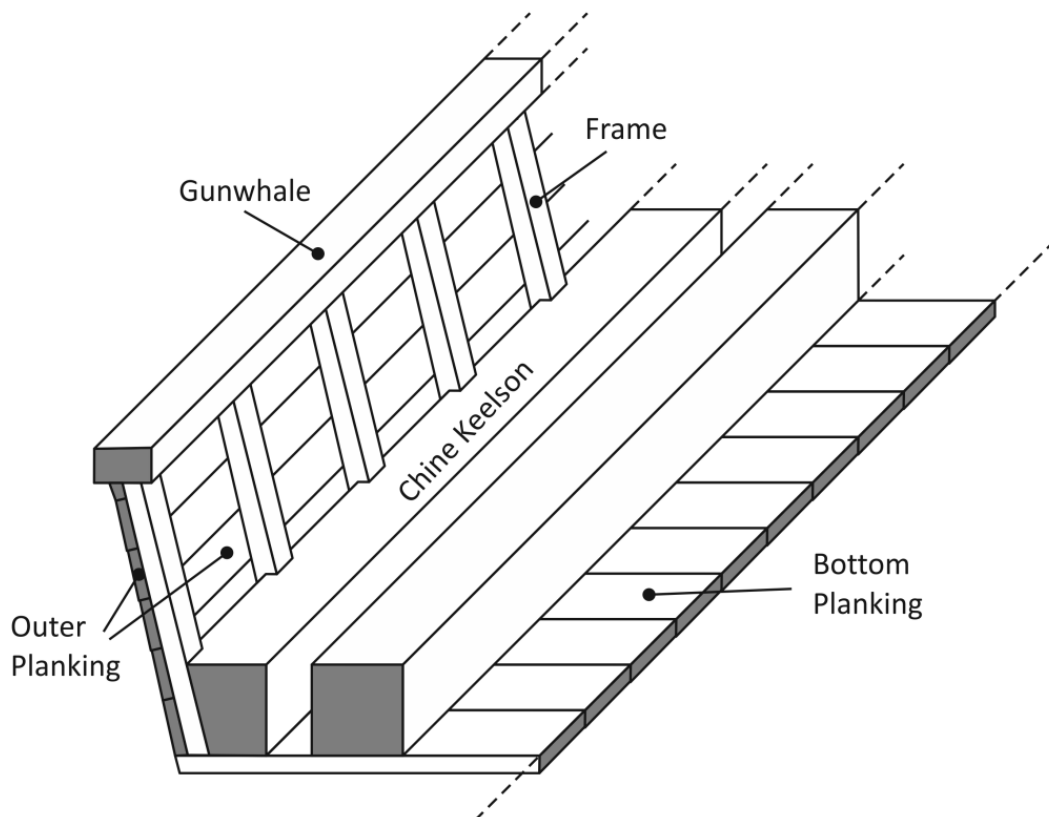
Figure 10. Simplified isometric reconstruction of the construction method used for the original vessel, showing the relationship between chine keelsons, bottom and side planking, amidships. Not to scale.

Based on the extant timbers currently visible at HYS, in conjunction with the available aerial photographs, it seems probable that the remains comprise some form of chine-built, flat-bottomed, wooden barge (Figure 10). There is no surviving indication of any propulsion, so the vessel may have been propelled by sail, by sweep/pole or simply been a dumb barge. The possibility must also exist that any engine and machinery has been salvaged from the hulk since its deposition. The presence of iron bolts and an iron knee, in conjunction with primarily wooden construction suggests a tentative date range between the mid/late 19<sup>th</sup> century and early 20<sup>th</sup> century. Although the vessel may be earlier than this, its material composition suggests that it is highly unlikely to be earlier than the mid-18<sup>th</sup> century.

Timber 1 and 3 represent the chine keels, also sometimes termed 'chine keelsons', of the vessel, to which upright frames were fitted into a series of rebates along the outer face. External planking was then fixed to these frames, extending the freeboard of the vessel. Timber 2 is harder to interpret, but the aerial photographs indicate that it must have formerly been a large internal longitudinal timber. It appears to be offset from the centreline in the aerial photographs and so probably had a matching timber on the other side of the vessel. The large area of planking represents the bottom planks of the vessel, which were formerly attached to the chine keels. The end of one plank indicates that this was achieved with square shafted iron nails, c.10mm in width. This method of construction would have produced a heavily-built, robust vessel capable of conveying a large quantity of cargo with only a limited draught. Ideal for shallow estuarine waters such as those found in the River Hamble.
